Urban Building Inspectors, Inc.

Building Inspection Report

Example Report

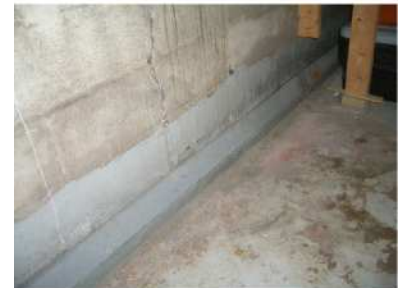
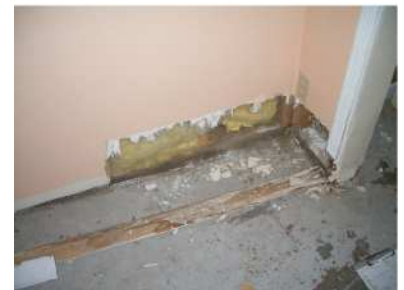
The basement shows evidence of past moisture penetration in the form of: (Damaged wall board in basement), (Installed beaver drain system, and past repair work being made on beaver drain system). Ask the sellers about past issues and damage in this area. These areas should be properly cleaned and repaired as needed.

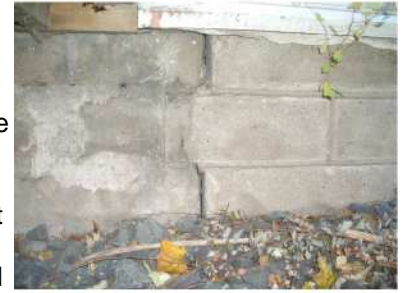
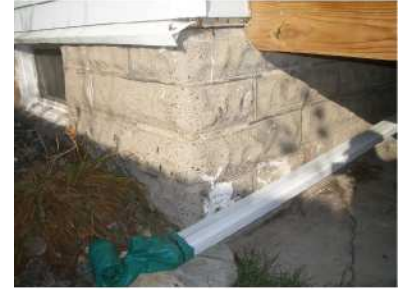
Shear cracks in the foundation were noted at the front of the porch, on the right side of the home, and at the back right corner of the home. It is suspected these cracks are structure in nature, and the number of vertical cracks and shear cracks in the foundation is considered above average, even for a home in this age range. There was no view of these cracks from the basement. (They were covered by wall board, insulation, or not in view). Predicting future movement of these cracks is beyond the scope of this inspection. It is recommended that the cracks be further evaluated and improved as needed by a licensed foundation contractor, or licensed structural engineer.

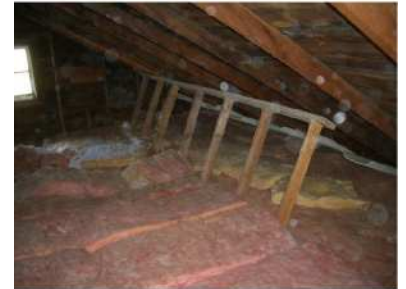
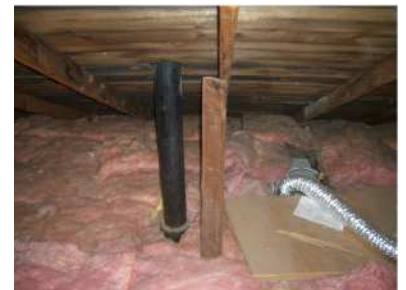
Additional vertical supports should be added in the attic for proper support of the rafters. Some rafters in the attic are properly supported, but many of the rafters do not have support. Some of the 2x4 supports are improperly installed. Notable roof sag was noted. Improvements are recommended for proper support of the roof rafters.

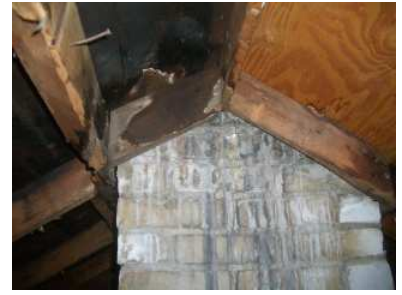
Evidence of mildew and past leaks were noted on the roof boards. Evidence of leaks were most notable around the chimney. Some of these blackened boards should be replaced when the roof is replaced.

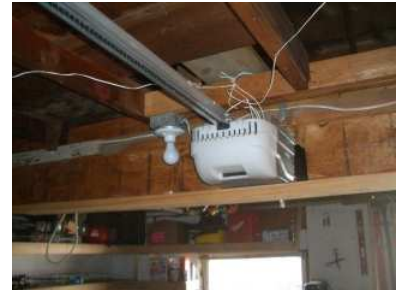
The beam in the garage has been notched out for the installation of the opener. This cut limits the strength and structural integrity of this beam. Heavy weights or storage should not be kept above this board unless further improvements are made.

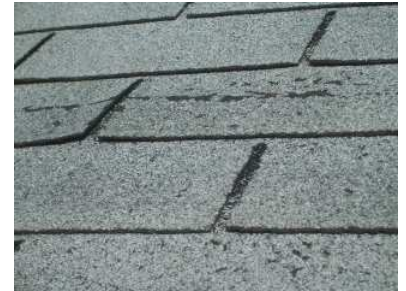
Shingles: Advancing wear on the shingles was noted. Areas of lost granules and possible past hail hits were noted on the right slope of the home. Inquiries should be made as to if hail has hit in the area, and if there has ever been a past insurance inspection done on the home. The roof is nearing the end of it's life cycle and should ideally by replaced within the next 2 to 3 years.

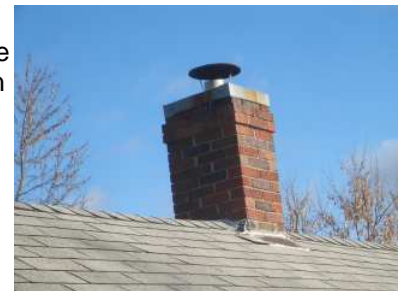
Masonry: The flashing around the chimney was rusted. There was also caulking noted around the flashing at the base of the chimney. This flashing should be replaced when the shingles are replaced.

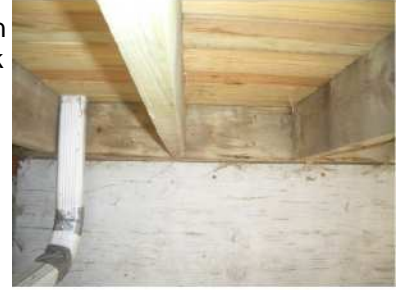
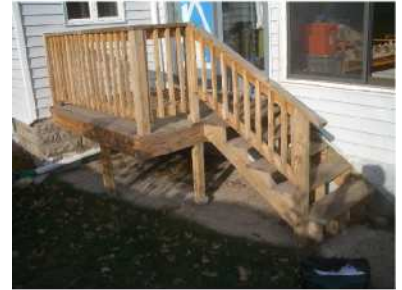
A proper flashing should be provided at the intersection of the ledger board and the house at the front and back deck/steps.

Proper lag bolts should be installed where the front steps and back deck attach to the house.

The post to beam connections on the deck should be improved.

The base of the back deck posts should be anchored. It does not appear there are proper footings for the back deck or front steps.

The front steps has settled to the left.

The opening at the bottom of the railing is large enough for a small child to fall through. The new code is 4 inches.

The back deck beam is not properly supported in the outer corner.

Proper improvements are recommended to the back deck and front steps to bring them up to current code and safety standards.

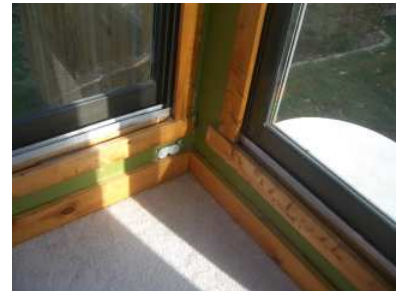
The glass on the exterior porch door was broken.

Repairs or replacement of the door is recommended.

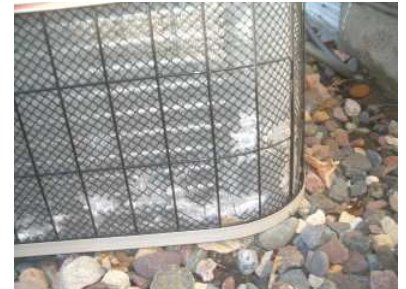
Outside Compressor: The fins of the outdoor portion of the air conditioning system were observed to be damaged. This condition can effect the proper operation of the system.

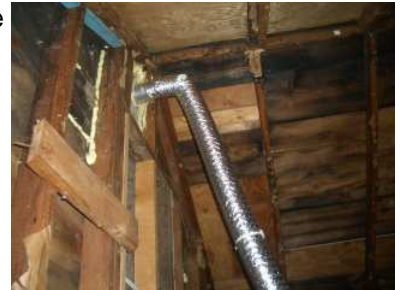
Attic: There was no insulation around the bathroom vent pipe in the attic. Insulation should be added to prevent condensation from forming.

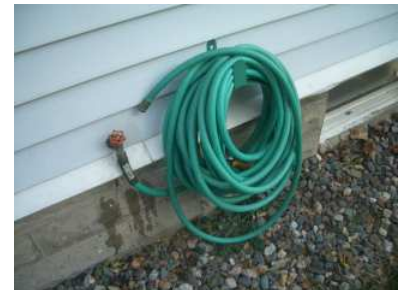
Exterior Hose Bibs: The exterior hose spigot should be properly winterized to prevent freezing.

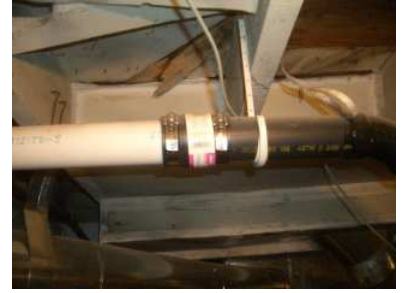
An improper rubber union was noted on the waste pipe in the basement. Rubber unions such as this should have metal bands around them.

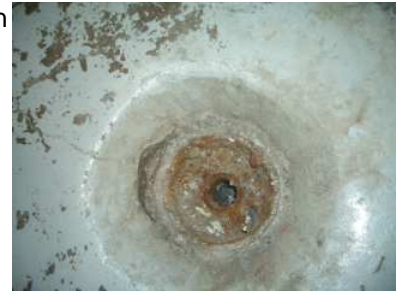
Some sections of the floor drain were rusted. This drain did function properly during the inspection. Periodic monitoring of this rust is recommended.

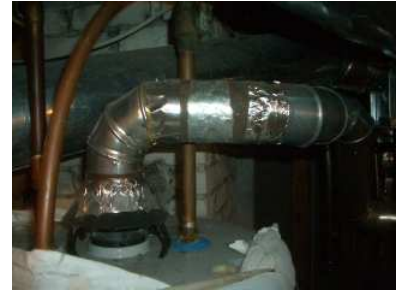
The vent pipe on the water heater is not properly sloped. There should be a 1/4 inch per foot rise on the vent pipe leading to the chimney. This is a potential safety hazard and should be further evaluated and improved by a licensed contractor.

An improper T-connection was noted where the water heater vent pipe connects to the furnace vent pipe. This connection should be made with a proper Y connection fitting to promote proper flow of exhaust toward the chimney.

The water heater vent pipe connections do not appear to be properly connected with 3 screws per connection. Heat tape is not sufficient on it's own to connect vent pipes. Additional screws should be added. Scorching around the heat tape was also noted. It appears the draft hood has been improperly bent downward in an attempt to make the vent pipe fit.

It appears the water heater may have been installed without a permit. It is recommended that a licensed plumber be hired to further evaluate the venting installation and to make the proper improvements.

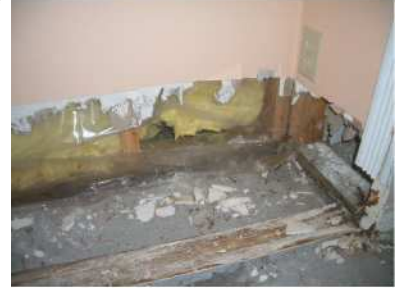
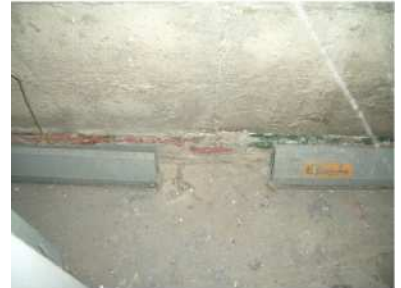
It appears the beaver drain system is damaged and is not functioning properly. Past attempts at repairs have been made as visible by the torn up wall board. A beaver drain system is not considered an efficient or reliable way to keep water out of a basement. The best solution is to install a drain tile system with a sump basket and sump pump.

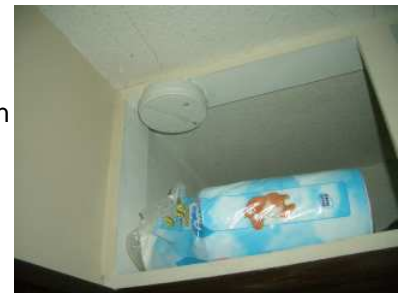
Location: A smoke detector is improperly located in the upper hallway cabinet frame. All smoke detectors should be properly installed as per local codes. Proper improvement is recommended. Further information can be obtained from the local city or code authority.

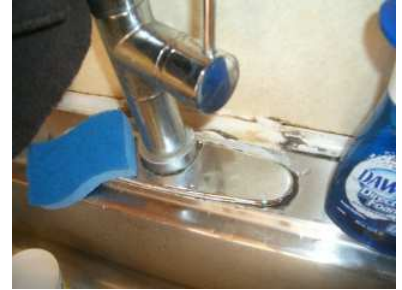
Water staining and damage was noted behind the kitchen sink. There was no leaking at the time of the inspection.

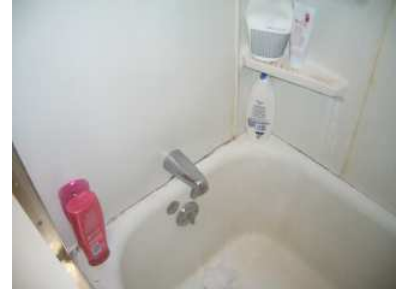
The loose caulk at the base of the shower surround should be improved.

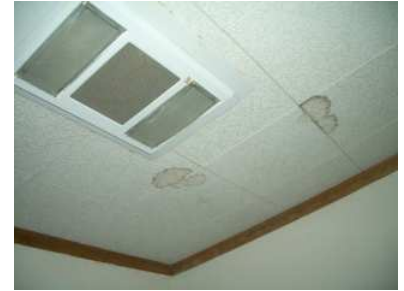
Condition: Stains were noted on the ceiling of the bathroom. These stains did appear dry at the time of the inspection. Ask the sellers if there have been any past issues in this area.
